Asbestos Survey

6081 OH-274; Huntsville, OH 43324

LUC Regional Planning Commission

Asbestos survey: 6081 OH-274; Huntsville, OH 43324

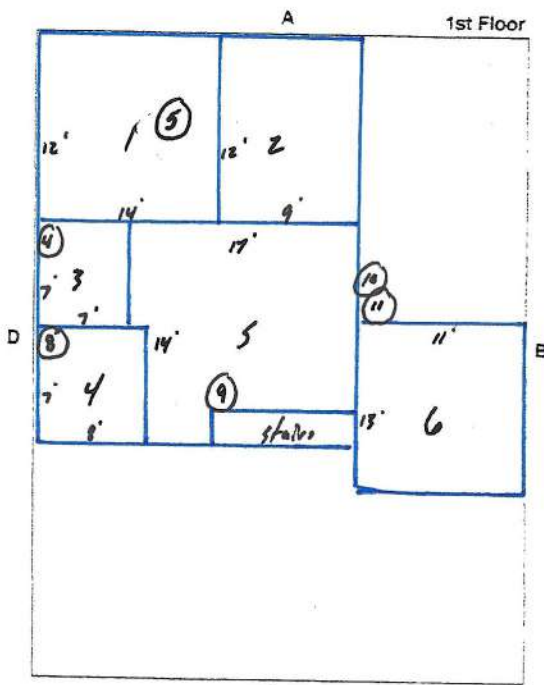
Ceiling Height 8ft

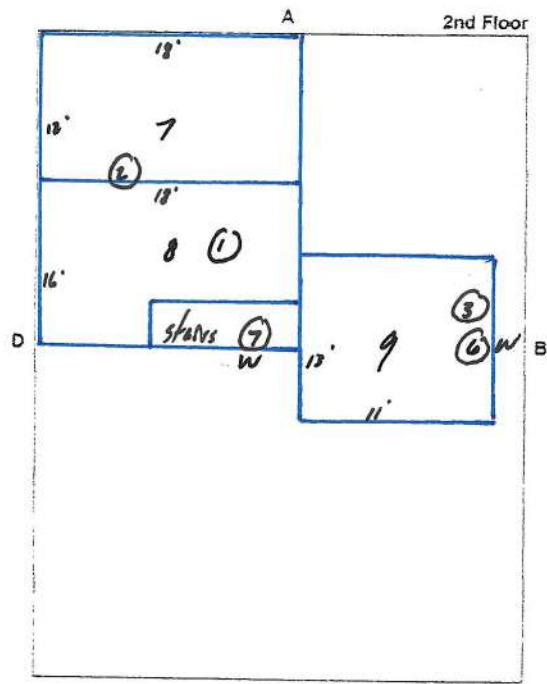
Ceiling Height 8ft
