**Asbestos Survey**

**728 N. Detroit St; Bellefontaine, OH 43311**

**Bell Hankins Realty Group, LLC**

Asbestos survey: 728 N. Detroit St. Bellefontaine, OH 43311

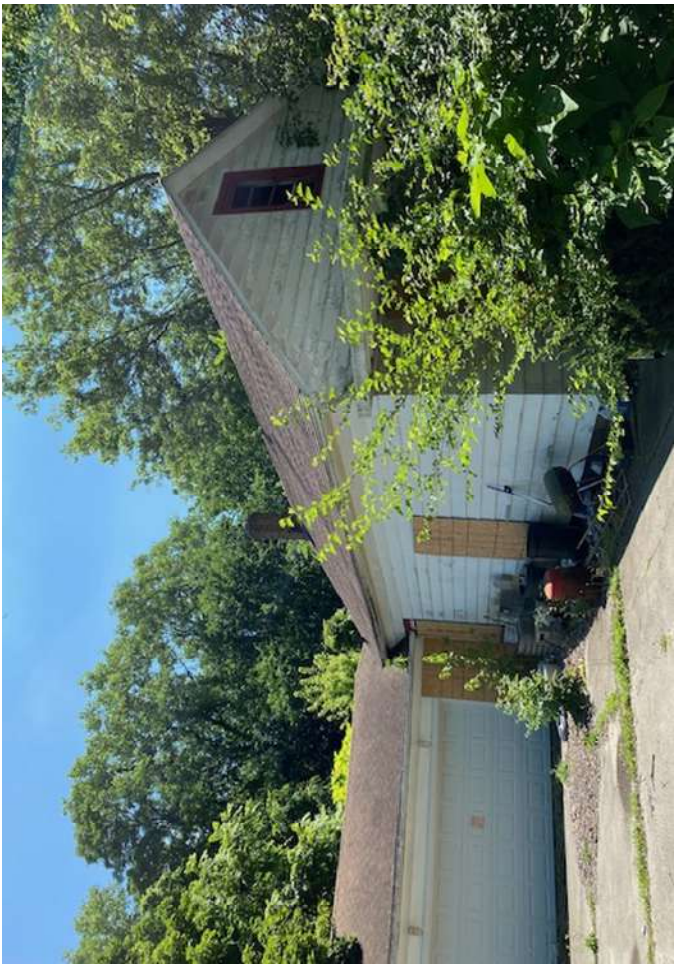
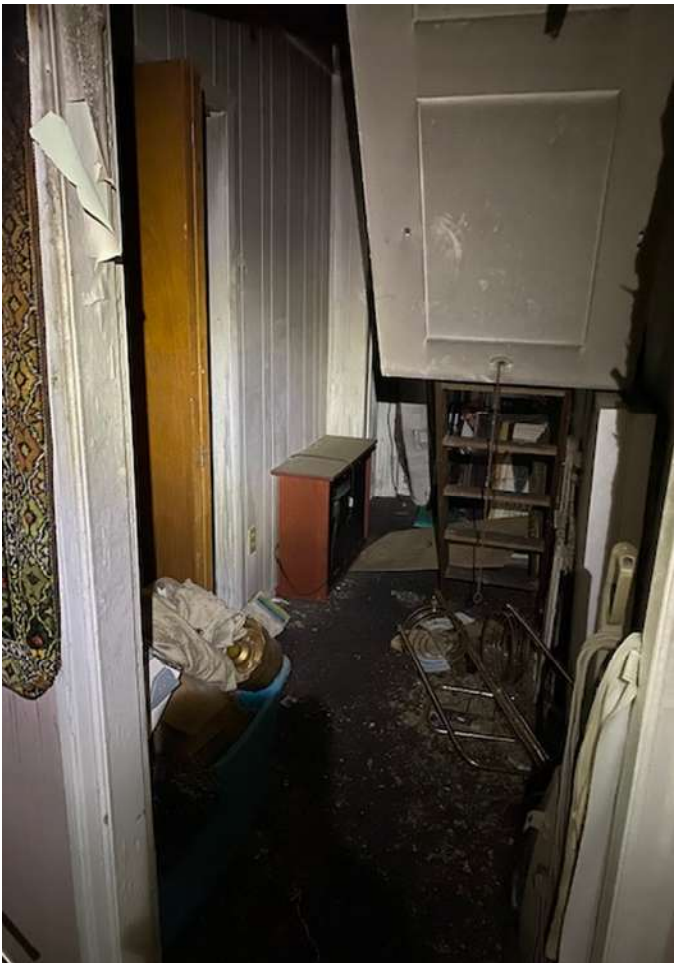
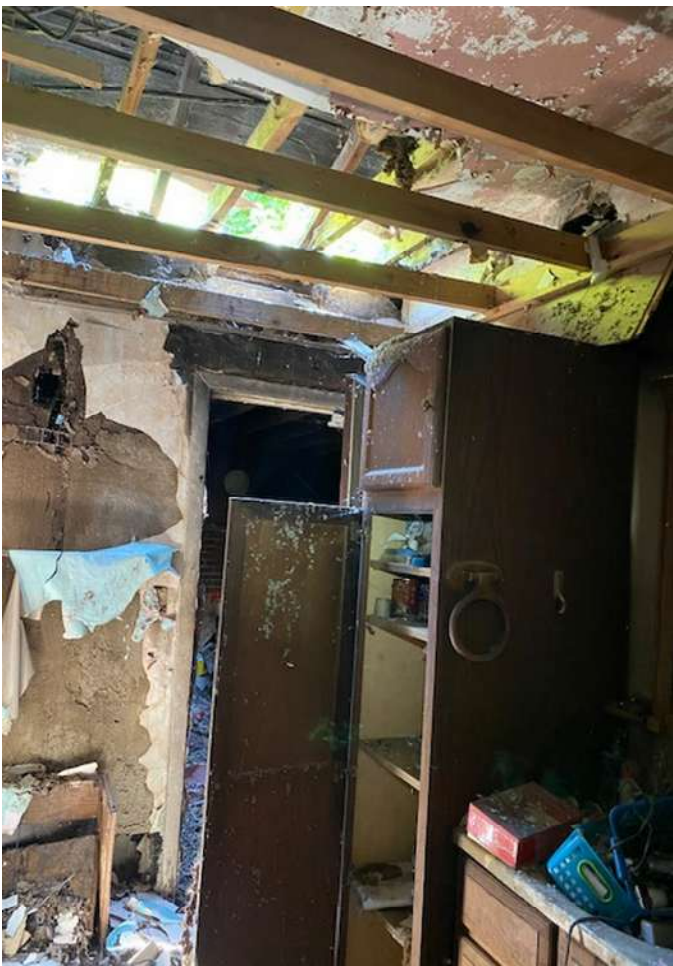
1. Asbestos Survey Cover
2. Asbestos Survey Letter
3. Purpose and Procedure
4. ACM Summary and Notice
5. Sample Chain-of-custody
6. Sample Site Pictures
7. Laboratory Analysis Report (and point-count analysis if applicable)
8. Asbestos Inspector Certifications

<b>H&amp;H Sample # Lab Sample #</b>	<b>Homogenous Area</b>	<b>Layers</b>	<b>Description/ Sample Location</b>	<b>PLM Result</b>
T-01 P7173HHE.2-01	1	2	Plaster Rm. 1 Wall A	ND
T-02 P7173HHE.2-02	1	2	Plaster Rm. 2 Wall C	ND
T-03 P7173HHE.2-03	1	2	Plaster Rm.3 Wall A	ND
T-04 P7173HHE.2-04	1	2	Plaster Rm.5 Wall D	ND
T-05 P7173HHE.2-05	1	2	Plaster Rm.6 Wall D	ND
T-06 P7173HHE.2-06	2	1	Window Glaze Rm.1 Wall D	ND
T-07 P7173HHE.2-07	2	1	Window Glaze Garage Wall B	ND
T-08 P7173HHE.2-08	3	1	Asphalt Siding outside Rm.1	ND
T-09 P7173HHE.2-09	3	1	Asphalt Siding outside Rm.2	ND
T-10 P7173HHE.2-10	4	2	Asphalt Roofing outside Garage	ND
T-11	4	2	Asphalt Roofing outside	ND

P7173HHE.2-11			Rm.2	
T-12 P7173HHE.2-12	5	1	T.S.I Duct Boot seam tape basement near furnace	10% Chrysotile
